ERDC/CERL TR-08-5, Vol. 1

Technology Demonstration of the Zero Emissions Chromium Electroplating System

Final Report

ABSTRACT: This report documents the demonstration of a technology developed by PRD, Inc, for control of chromium emissions during hard chromium electroplating, the Zero Emissions System. The technology involves placing a blanket of a proprietary fluid, called PRD-EL1, on top of the plating bath. This fluid blanket prevents the formation of aerosols, which is the mechanism by which chromium is emitted from the plating bath to the air. The majority of the testing was directed at demonstration of the effectiveness of chromium plating in the presence of the immiscible blanket. Testing was conducted at Benét Laboratories on coupons and actual parts from Army vehicles. The results indicate that PRD-EL1 may cause deleterious effects on the plating process, as some of the parts failed qualitative tests performed at Benét. However, some parts, which were plated without the fluid blanket present as a baseline control, also failed the tests. Air sampling results indicate that the presence of the PRD-EL1 fluid reduced the chromium emissions to below the standard and the indoo

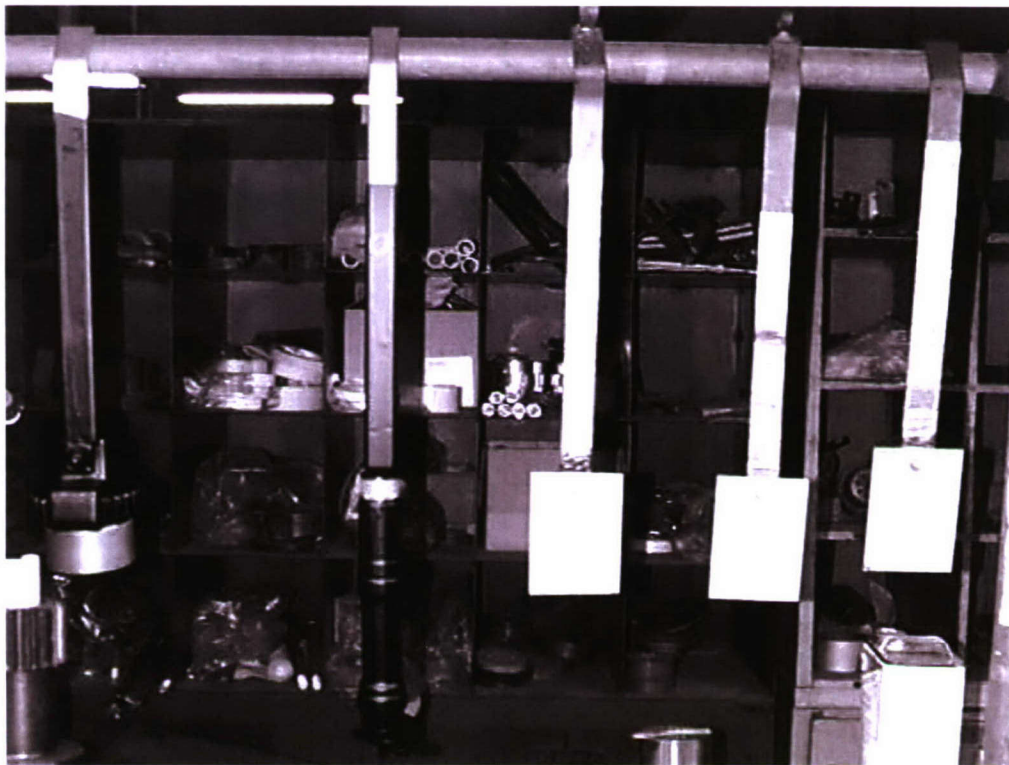
Figure 3. Test parts positioned on handling systems.

During Phase II, the baseline test was conducted last. PRD-EL1 liquid was added to the tank at various locations in preparation for the first plating cycle. Several parts were plated with an initial PRD-EL1 depth of 4-in., followed by another plating run with the PRD-EL1 fluid maintained at a depth of 2 in.

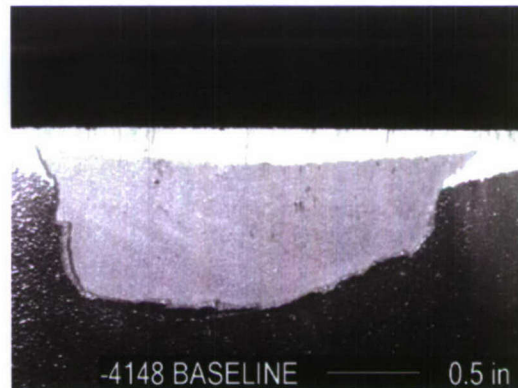
Figure 22. Failed sample (4148 Baseline).

The ASTM specification states that lifting or peeling of the coating is evidence of unsatisfactory adhesion. Figures 21–24 show some failed samples.

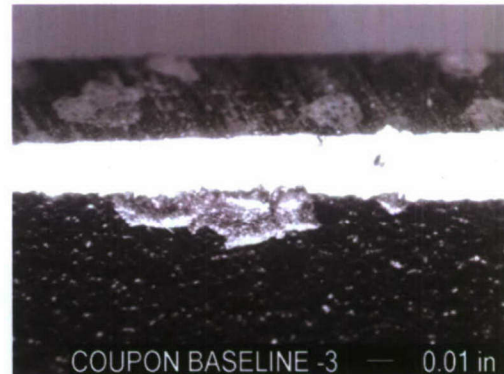
Figure 24. Failed sample (Coupon Baseline).
